MISCELLANEOUS PAPER NO. 6-761

SONISCOPE INVESTIGATION OF ELMENDORF AFB HOSPITAL ANCHORAGE, ALASKA

December 1965

U. S. Army Engineer Waterways Experiment Station
CORPS OF ENGINEERS
Vicksburg, Mississippi

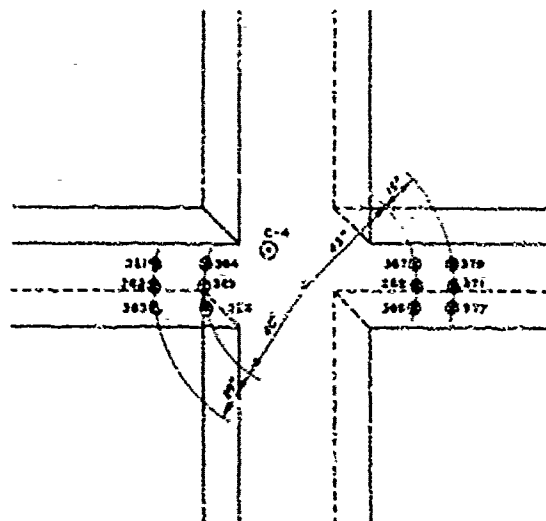
Station location diagram

Readings Through Beams, Columns, and Column-Beam Connections
(South Side)
(Grouted)

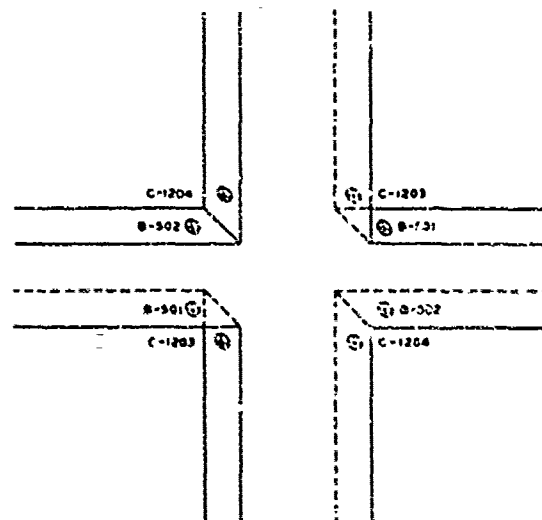
Station location diagram

17. Velocity measurements were made through the outer 6 in. of column-beam connections on the fifth floor, north side of building, at columns 12 and 10. Results (tables 28 and 29) indicated these connections to be very good at column 10. Three of four measurements at column 12 indicated a good condition.

Results of Soniscope Tests
 5th Floor Spandrel Beam at Column 12
 Column-Beam Readings Through Outer 6 in.
 North Side of Building

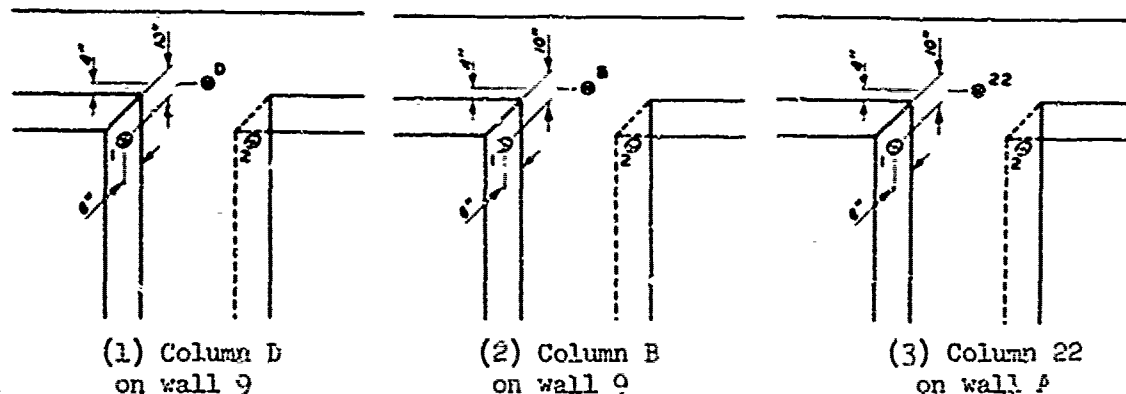
A. Column-beam connections (grouted)

20. Eight readings were taken at five exterior columns around the outpatient clinic (fig. 6) in an attempt to determine the effectiveness of the epoxy repair. Inaccessibility of interior faces of these columns and beams limited the type and number of readings that could be taken. The location and results of these readings are given in table 35.

Table 35
Results of Soniscope Tests
 Readings on Column-Beam Connections
 Around Outpatient Clinic
 (Grouted)
